Citation: Lan, X., Li, Z., Fu, F. & Qian, K. (2023). Robustness of Steel Braced Frame to Resist Disproportionate Collapse Caused by Corner Column Removal. *Journal of Building Engineering*, 69, 106226. doi: 10.1016/j.jobe.2023.106226

1 **Robustness of Steel Braced Frame to Resist Disproportionate Collapse Caused by** 2 **Corner Column Removal**

22 **Author Keywords:** Disproportionate collapse; Corner column; Steel frame; Braces; Test

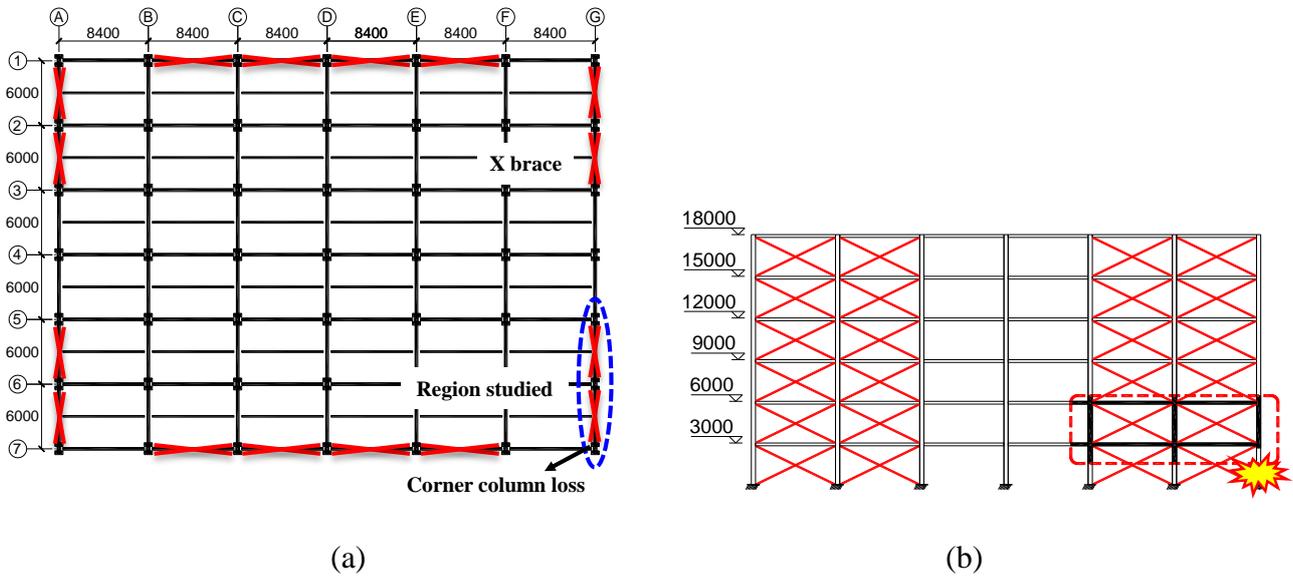
Fig. 1. Prototype building and extracted frame (unit in mm): (a) front view; (b) side view

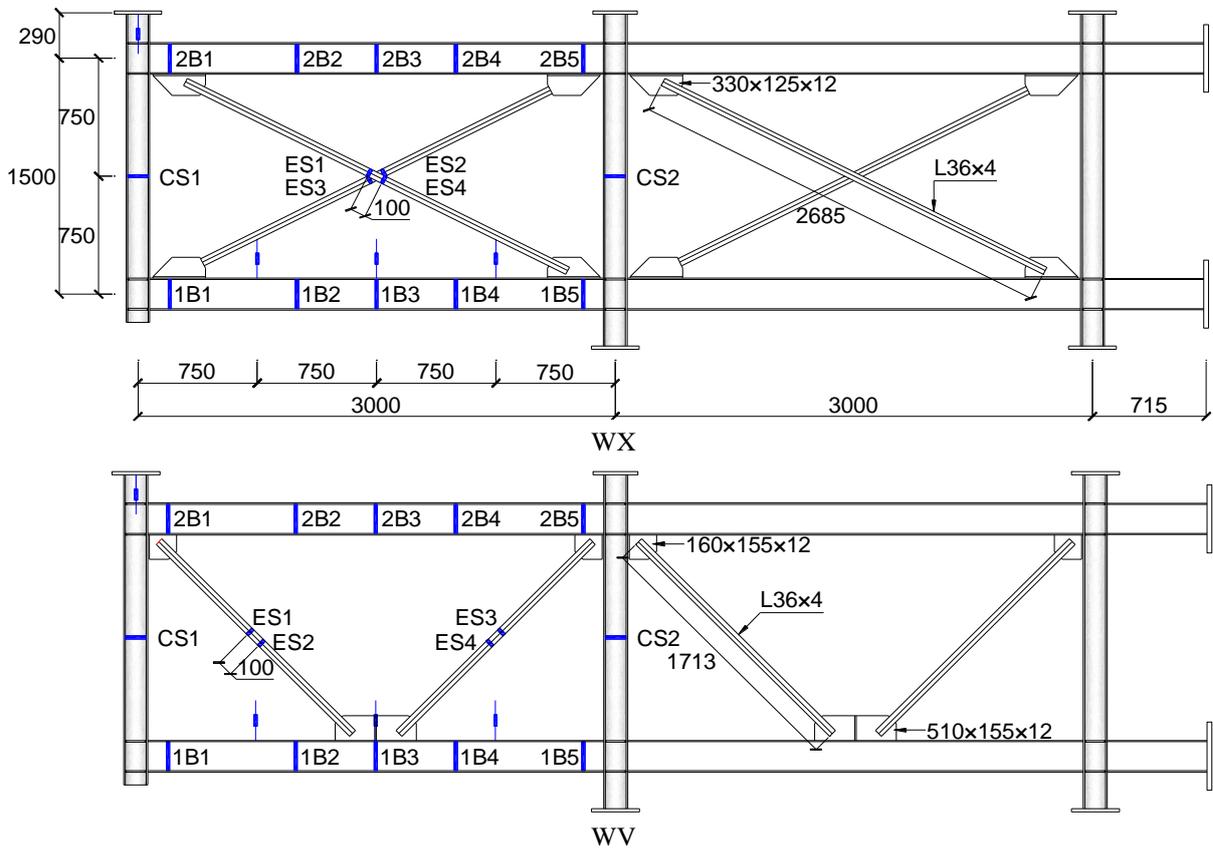
Fig. 2. Dimensions of the specimen and locations of instrumentations: (a) layout of strain gauge and displacement transducer; (b) position of strain gauges on sections

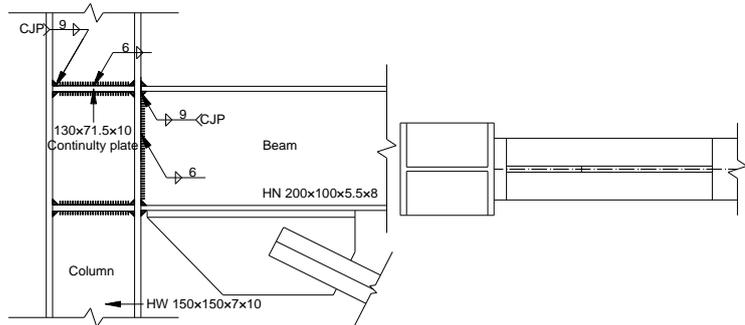
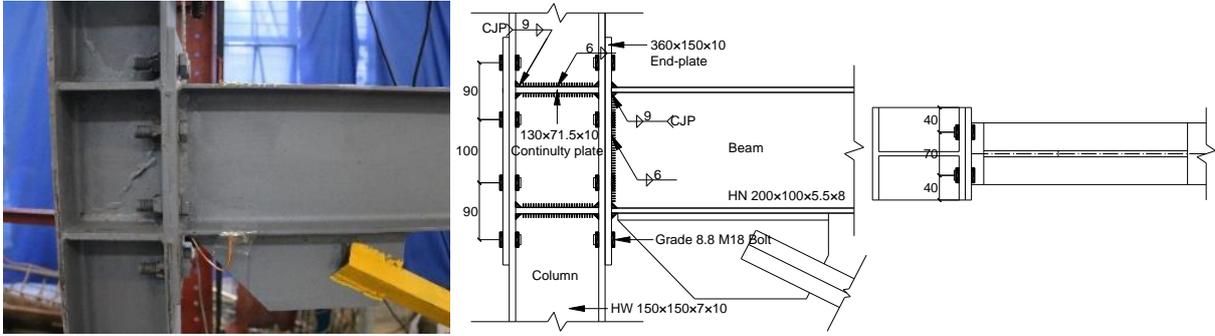
Fig. 3. Details of the connections: (a) welded connection; (b) end-plate connection

94 welds were used to connect the beams and columns. For end-plate connection, the beam was welded
95 to an end plate with thickness of 10 mm. Eight M18 Grade 8.8 frictional bolts are employed for bolt
96 connection with a pre-loading force of 345 N·m. The braces and the connections were designed based
97 on ANSI/AISC 341-05 [19]. The braces and beams are connected by the gusset plates welded to the
98 beam flanges. The uniform force method was employed to determine the force acting on welds [26].
99 To avoid the gusset plate premature yield and fracture occurred in the gusset plate before braces failure,
100 the gusset plate is designed relatively stronger [19, 21]. Taking WX and EX as an example, the braces
101 were made by steel angles with a dimension of $36 \times 36 \times 4$ mm as shown in Fig. 2a. WX and EX have
102 X shaped braces and the size of gusset plate is $330 \times 125 \times 12$ mm. In addition, WV has V shaped braces.

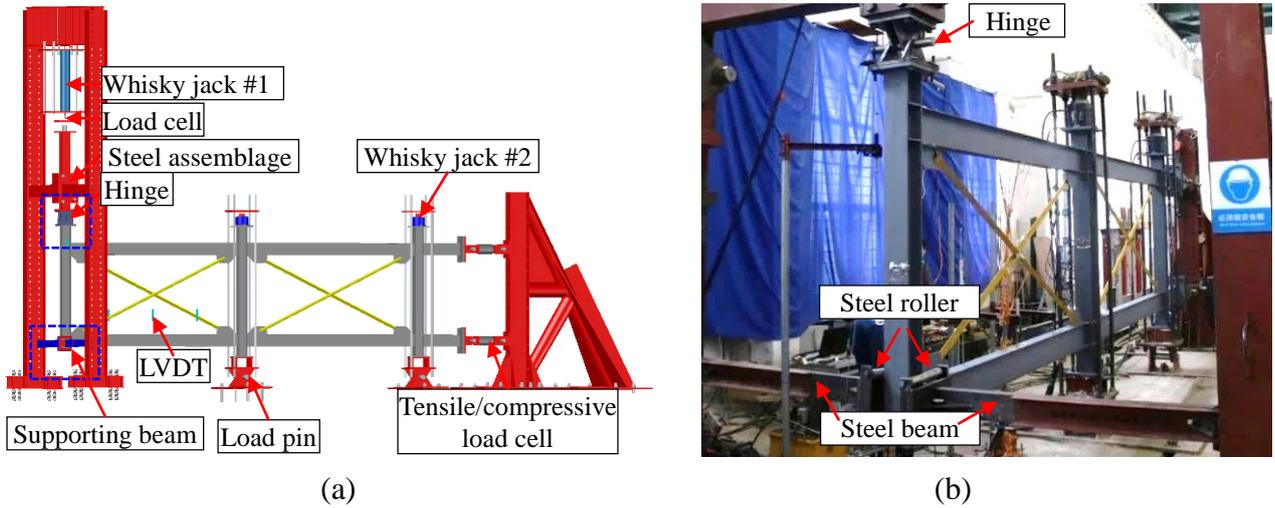
Fig. 4. Test setups of WX: (a) drawing; (b) photo

111 As illustrated in Fig. 4a, the ground corner column was not assembled to represent the initial
112 damage. Beneath each side column, a pin support was applied. The vertical load was imposed at the
113 top of corner column through a whisky jack. Displacement-controlled loading method was adopted. At
114 the beginning of the test, a loading rate of 5 mm/min was set until reaching the vertical displacement
115 of 100 mm. In the subsequent loading process, the loading rate of 10 mm/min was adopted. The applied
116 concentrated load was monitored by a load cell, which was placed beneath the whisky jack. To prevent
117 undesirable out-of-plane failure, a steel assemblage was specially arranged.

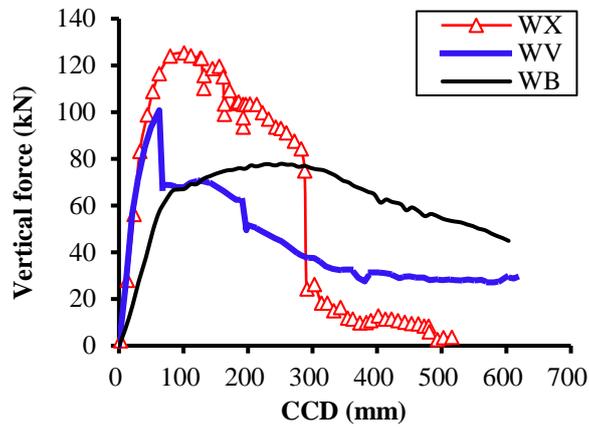
Fig. 5. Load-displacement curves of specimens: WB, WX and WV

159 **WV:** For WV, it has a yield load of 93.5 kN and initial stiffness of 1.9 kN/mm. Similar to WX,
160 the compressive braces began to out-of-plane buckling at the very beginning of the load. Different from
161 WX, the tensile brace fractured at a relatively early stage (corresponding to CCD of 63 mm) and
162 followed by the drop in load resistance dramatically. Moreover, it has an ultimate load bearing capacity
163 of 100.9 kN, which is 129.0% and 80.5% of that of WB and WX, respectively. When the fracture
164 occurred at the beam ends, the load resistance dropped significantly. After reaching the CCD of 191
165 mm, the load bearing capacity of WV became even lower than that of WB. Fig. 8 displays the failure

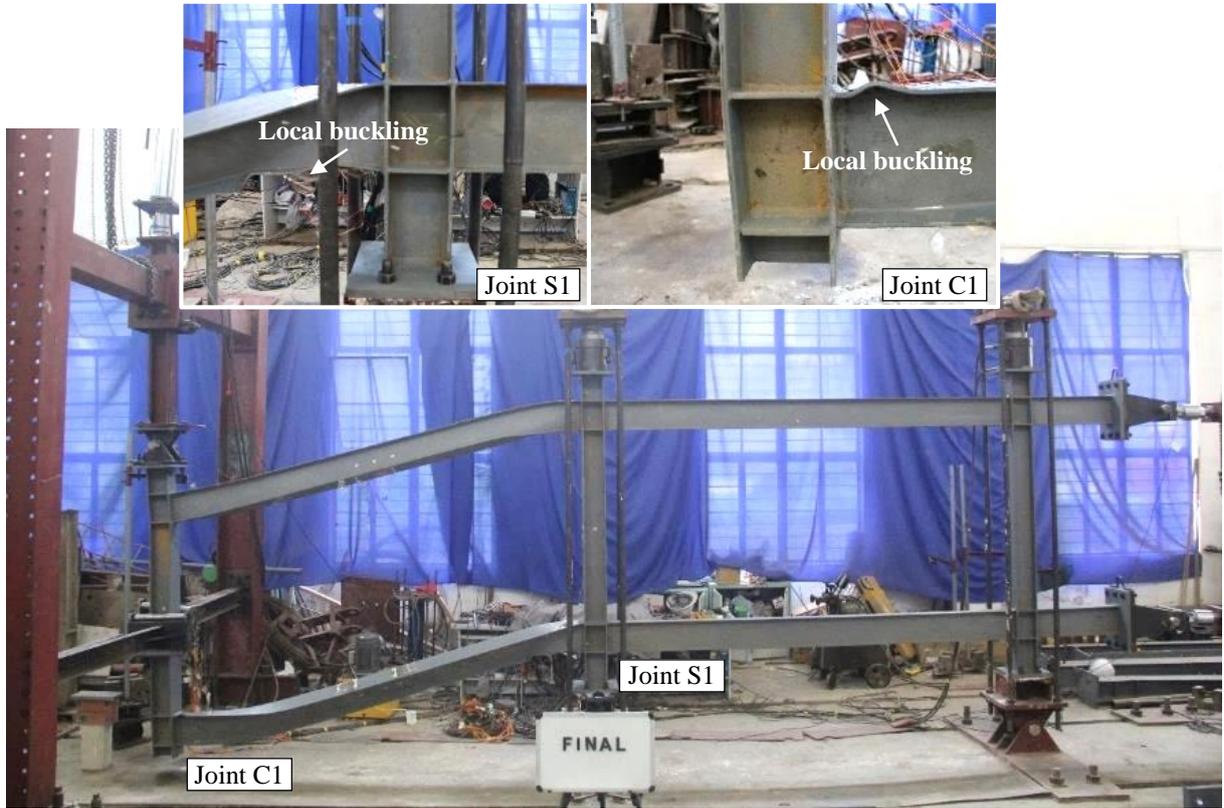
Fig. 6. Failure pattern of Specimen WB

142 **was reached.** On further increasing the displacement, similar local buckling also occurred at beam
143 flanges in the second floor at CCD of 400 mm. Fig. 6 shows the failure pattern of the specimen.
144 Although no fracture occurred during the test, the local buckling was severe at the beam ends, which
145 resulted in the beam of the first floor failing in torsion in absence of catenary action.

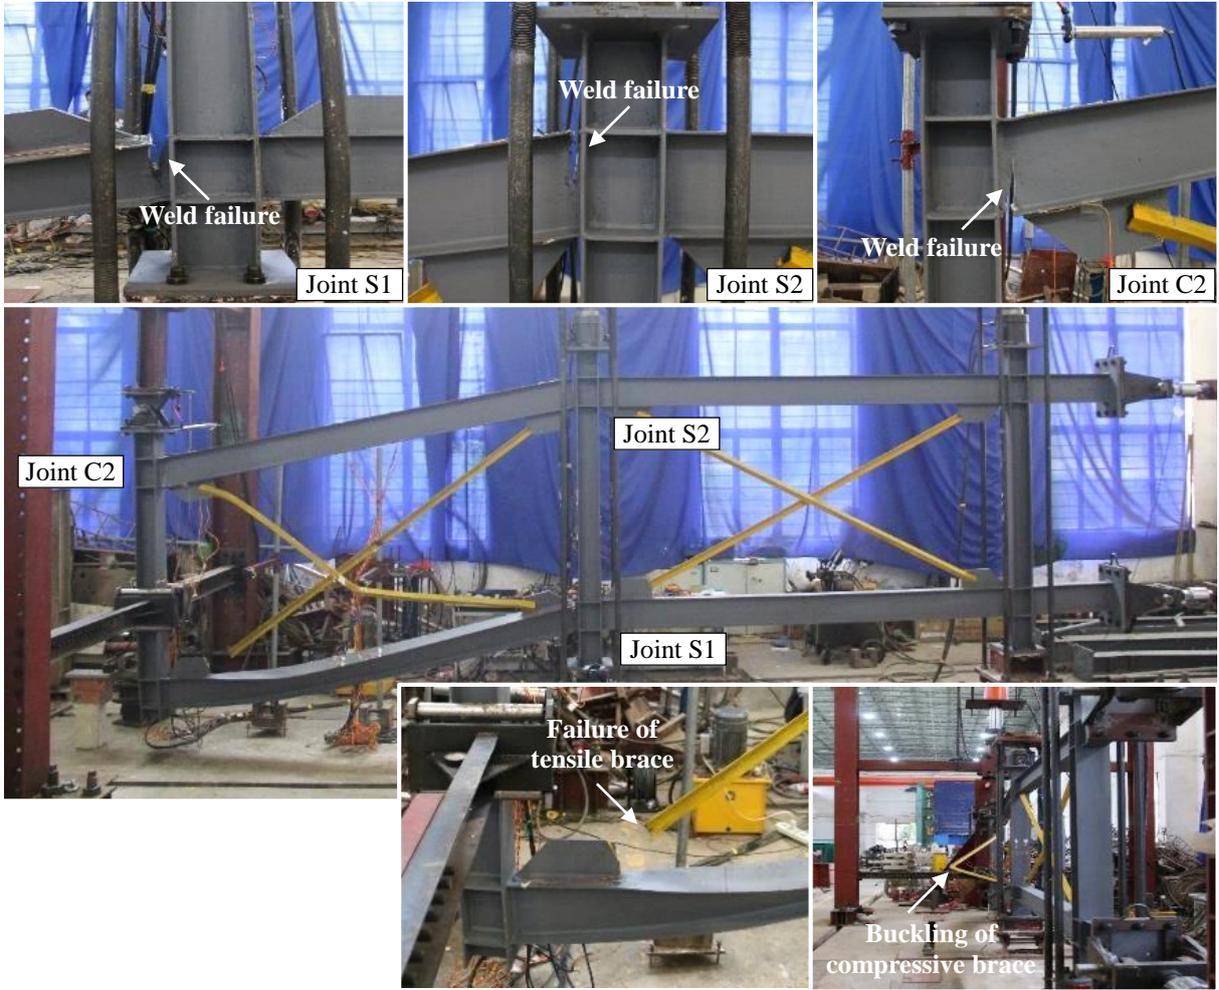
Fig. 7. Failure pattern of Specimen WX

146 **WX:** As the second floor has X braces, the failure pattern of WX was changed. In the start of
147 testing, the compressive braces started to buckle, which indirectly showed that the compressive braces
148 may have little contribution to the load enhancement. This can be confirmed by the strain gauge results
149 later. As displayed in Fig. 5, it has a yield load of 116.5 kN at an CCD of 62 mm. Moreover, it has
150 initial stiffness of 1.9 kN/mm, about 232.3% of that of WB. Similar to WB, local buckling of the bottom
151 beam flange occurred near the side column in the ground floor at this stage. It has an ultimate load
152 bearing capacity of 125.4kN. The tensile brace fractured at an CCD of 288 mm, which leads to the load
153 resistance dramatically dropping from 74.9 kN to 24.3 kN. Fig. 7 gives the failure pattern of the
154 specimen. Tensile braces were fractured and compressive braces were severely buckled. No yielding

155 was observed in the gusset plates. Similar to WB, torsional damage occurred in the beam in the first
156 floor. **However, premature weld fractures occurred in Joints S1, S2 and C2 of WX, which were not**
157 **observed in WB. This was due to the additional shear forces from the steel braces and the torsion-**
158 **induced shear forces in the beams.**

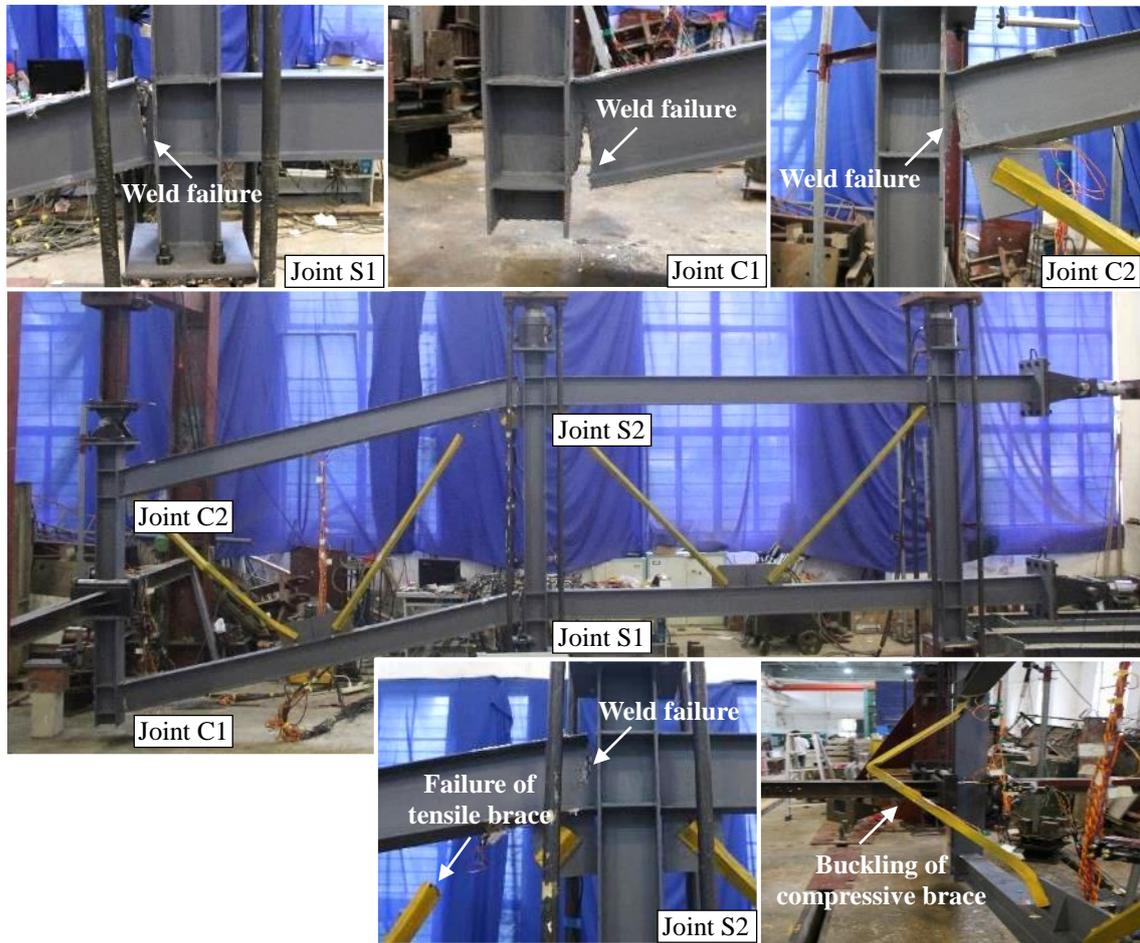
Fig. 8. Failure pattern of Specimen WV

166 pattern of WV. Similar to WX, the compressive braces suffered severe buckling and the tensile braces
167 were fractured. However, different from WX, there is no torsional damage occurring in the beams with
168 gusset plate welded to the beam flange were enough to prevent torsional buckling.

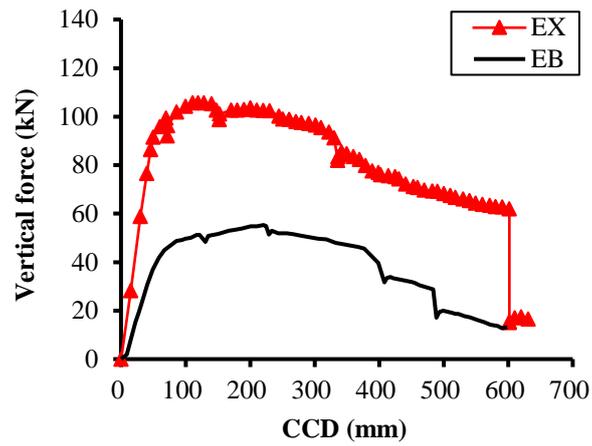
Fig. 9. Load-displacement curves of specimens: EB and EX

169 **EB:** Fig. 9 compares the load-displacement curves of EB and EX. EB achieved a yield load of
170 42.7 kN and initial stiffness of 0.7 kN/mm. When the CCD reached 135 mm, the welds nearby the side
171 column in the second floor fractured. Subsequently, the load bearing capacity could increase until
172 further weld fracture occurred at the end-plate. It has an ultimate load bearing capacity of 55.5 kN.
173 Similar fractures occurred at the beam ends near the corner column at CCD of 406 mm and 487 mm,
174 respectively. Fig. 10 gives the failure pattern of the specimen. The failure of EB was controlled by weld
175 failure at the end-plate.

176 **EX:** It has a yield load of 86.4 kN and initial stiffness of 1.9 kN/mm. The weld fracture was
177 initially developed nearby the corner column. With the displacement kept increasing to 128mm, EX
178 reached its ultimate load bearing capacity of 105.8 kN. When CCD increased to 159 mm and 336 mm,
179 the welds fracture was formed at the beam ends in sequence. The tensile braces fractured at an CCD of
180 602 mm, which was 109.0% later than WX. Fig. 11 gives the failure pattern of EX. Similarly, the
181 compressive brace suffered severe out-of-plane buckling while the tensile brace fractured. Moreover,
182 local buckling occurred at point A.

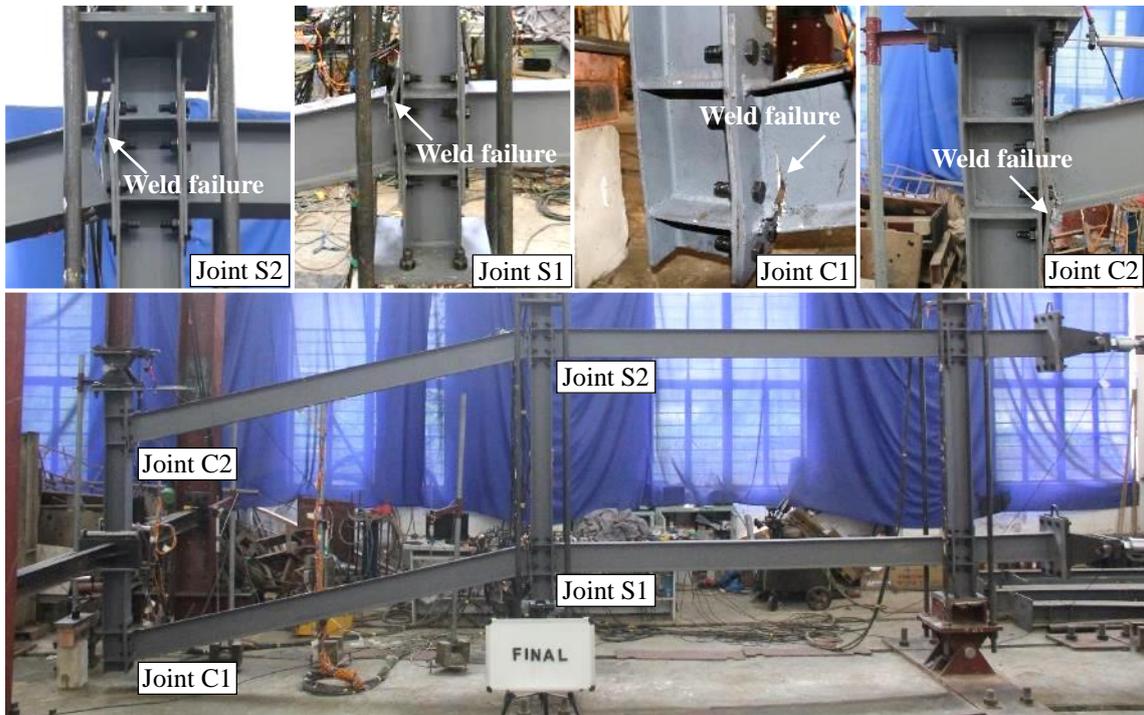
Fig. 10. Failure pattern of Specimen EB

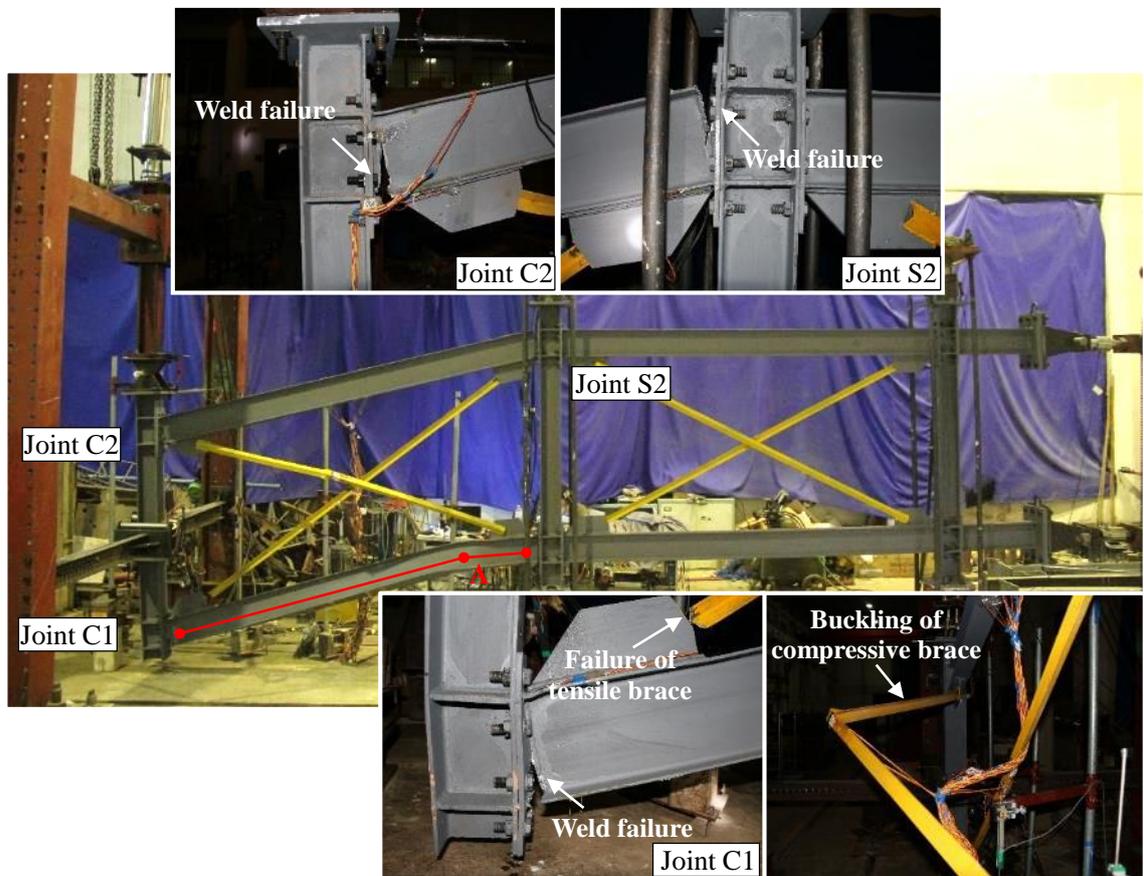
Fig. 11. Failure pattern of Specimen EX

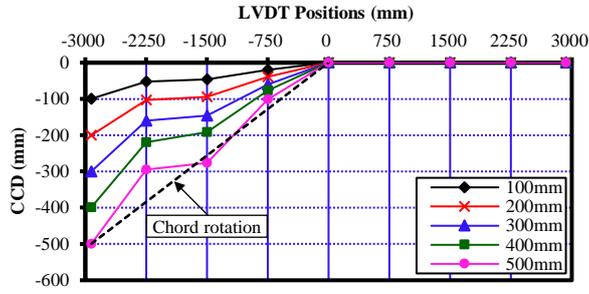
Fig. 12. Deflection profile of the beams in different stages: (a) WB; (b) WX; (c) WV

279 deformation of WX was 457.1% of that of WV. Regarding to failure patterns, as shown in Fig.12,
280 torsional damage occurred at interfaces between the beam and corner column joint of WB and WX [35,
281 36]. However, due to the gusset plate of V bracing configuration, the critical beam section shifted close
282 to the beam midspan, which prevented the torsional damage of WV [37].

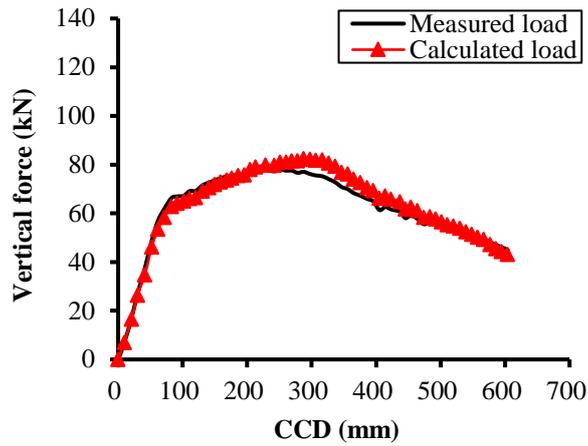
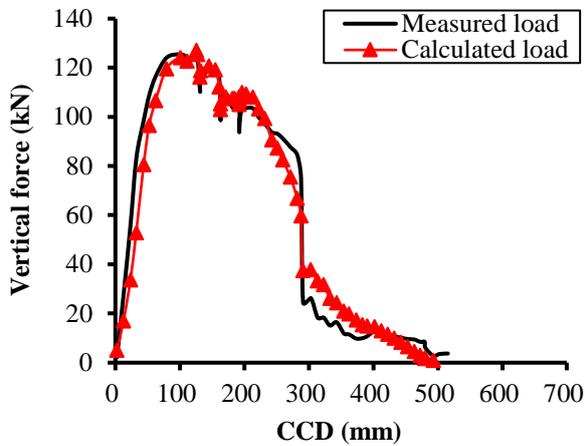
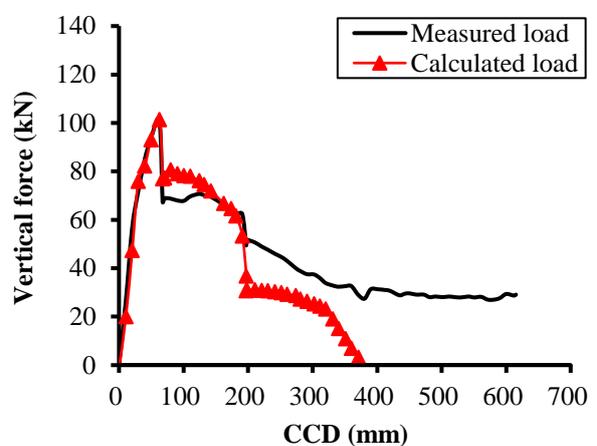
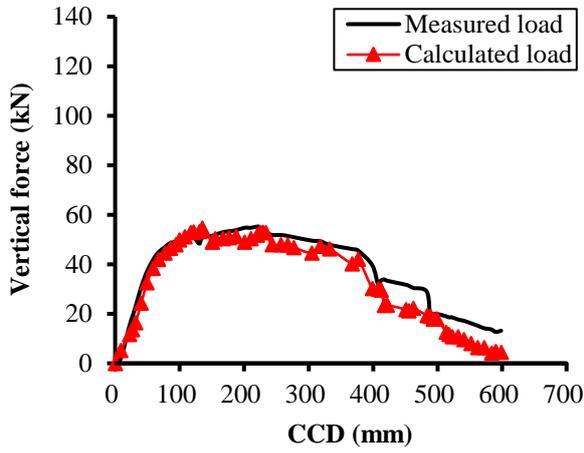
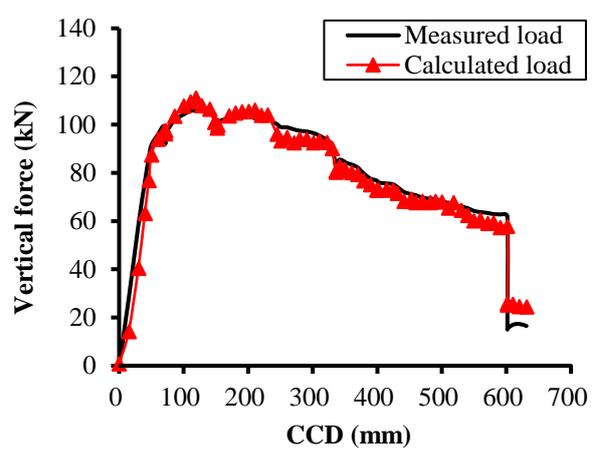
Fig. 13. Load-displacement curves from strain gauge and load cells: (a) WB; (b) WX; (c) WV; (d) EB; (e) EX

200 placed above the corner column. Generally, the analytical results based on strain gauges can well
201 capture the character of the curve until failure.

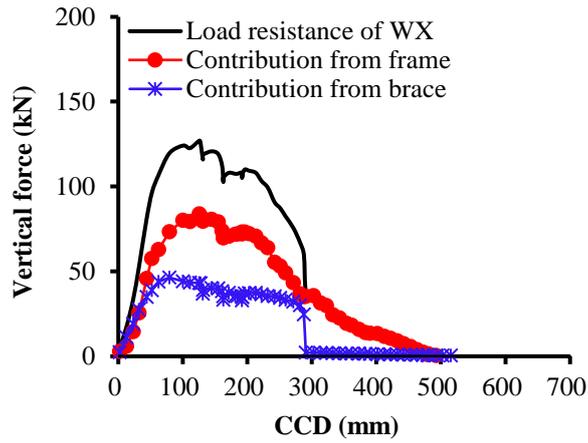
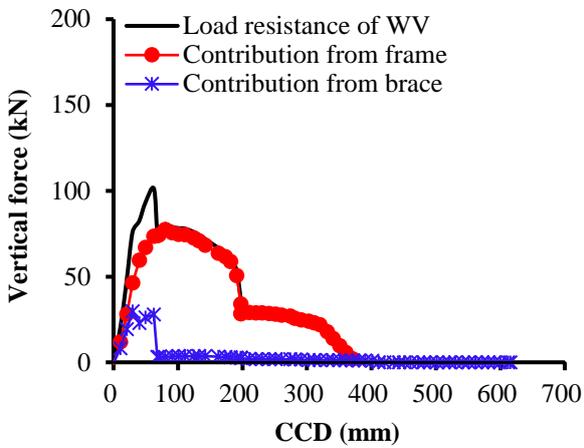
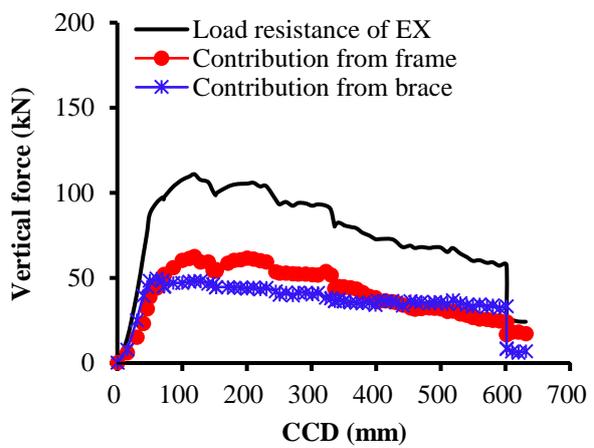
Fig. 14. De-composition of the load bearing capacity from frame and braces

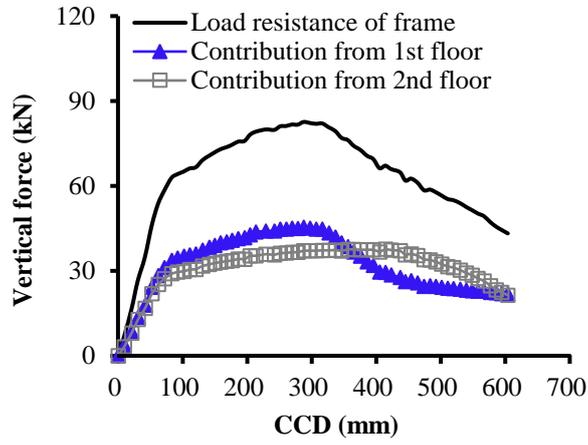
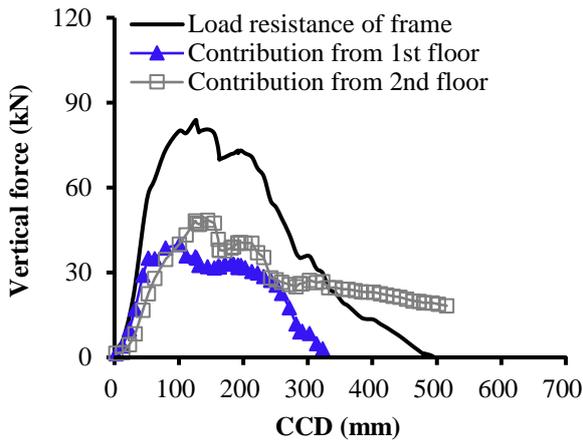
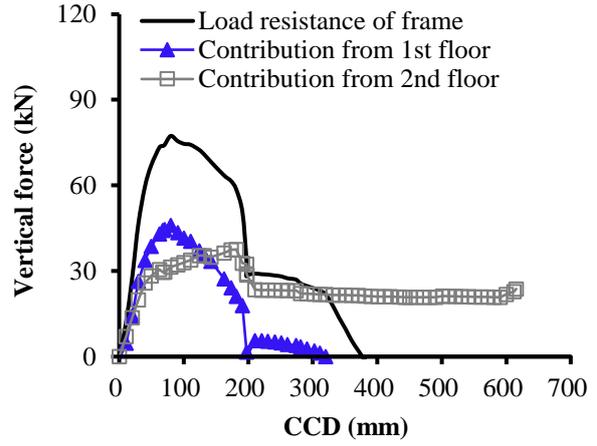
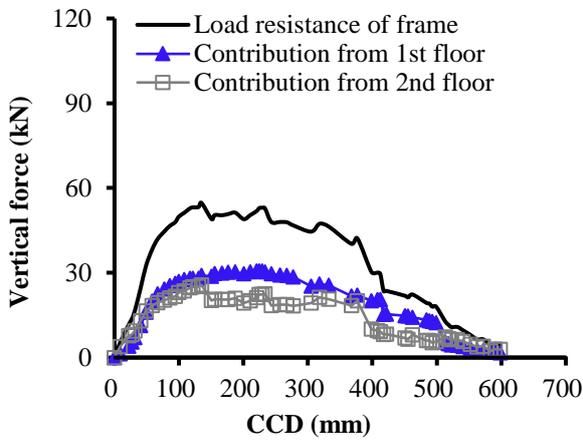
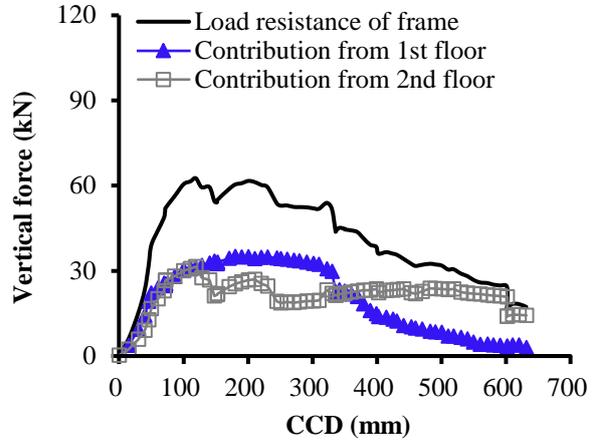
Fig. 15. De-composition of load bearing capacity from the 1st floor and 2nd floor

216 The de-composition of the frame contribution from each floor is given in Fig. 15. As shown in the
217 figures, the load bearing capacity from the first and second floor has similar trends until failure occurred
218 in the connections, while the first floor has slightly greater load resistance than that of second floor.
219 This was due to the greater rotational constraints and Vierendeel action, for which further explanation
220 would be in section 4.2. However, WX had a greater maximum load resistance from the second floor
221 as the connection in the first floor fractured earlier.

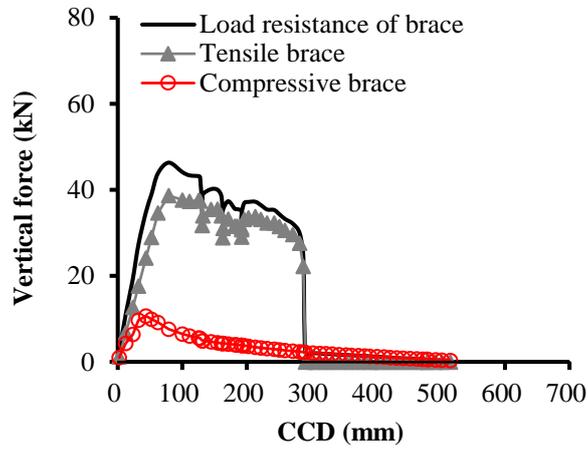
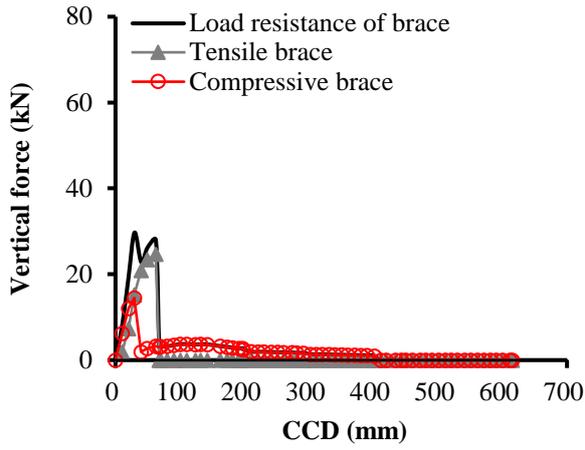
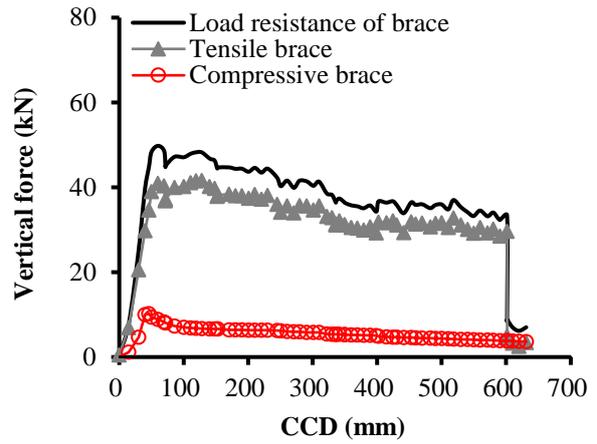
Fig. 16. De-composition of the load bearing capacity from tensile brace and compressive brace

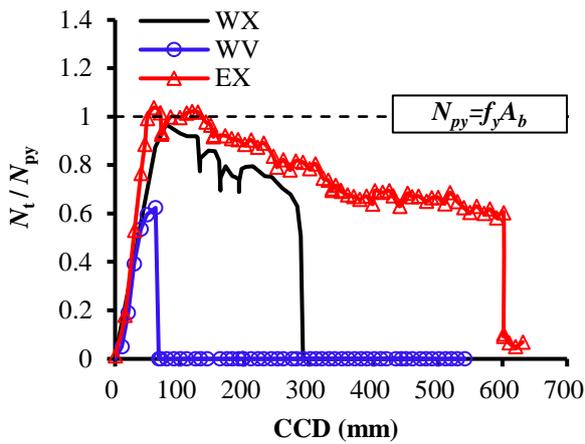
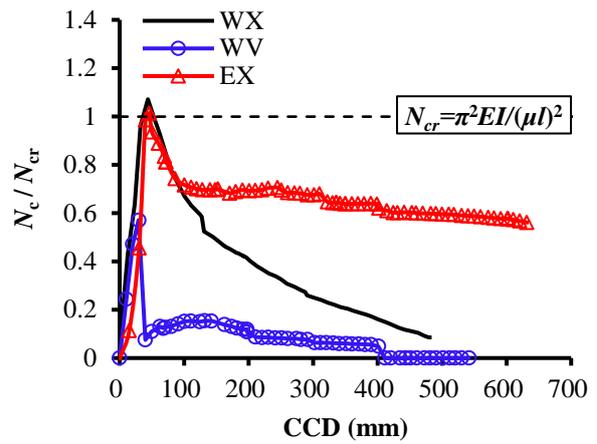
Fig. 17. Axial force of braces: (a) tensile brace; (b) compressive brace

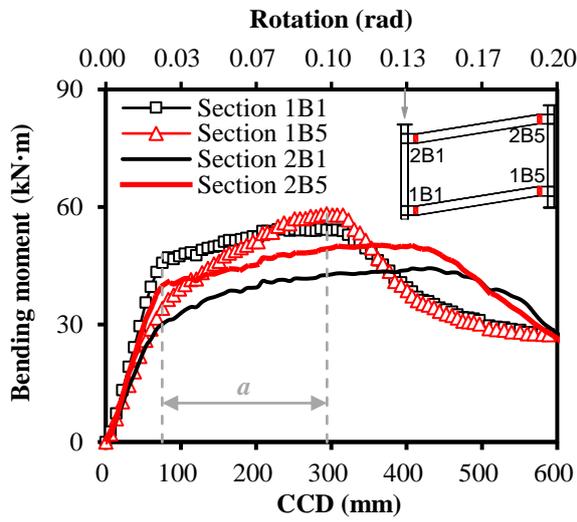
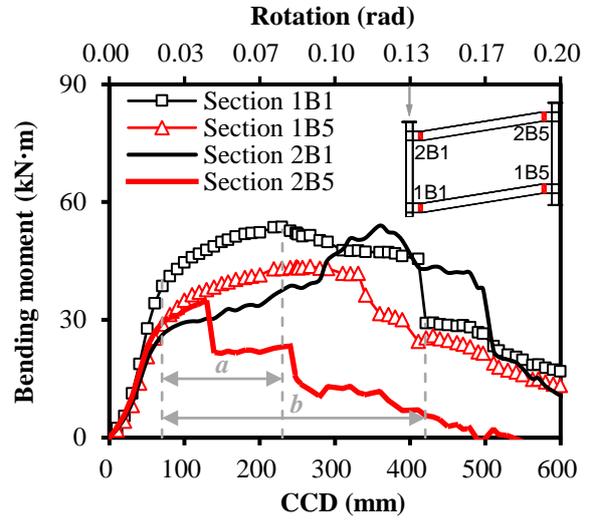
Fig. 18. Bending moment development at the beam ends: (a) WB; (b) EB

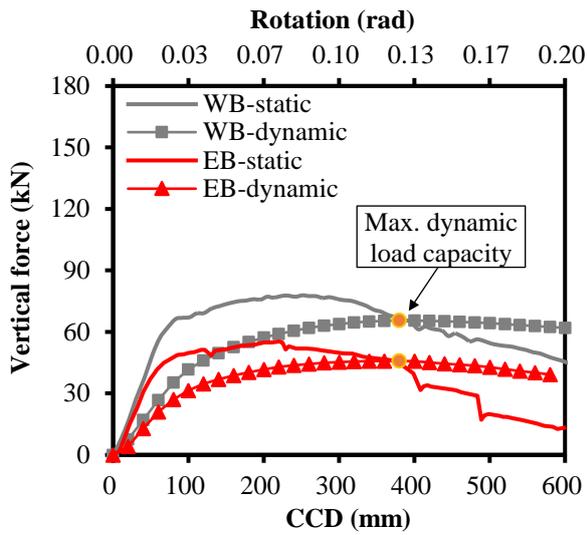
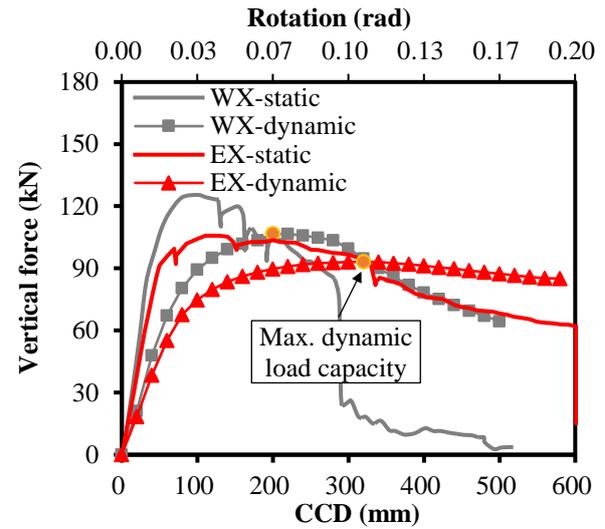
Fig. 19. Comparison of the static and dynamic load resistance: (a) WB and EB; (b) WX and EX

261 As labeled in Fig. 19, the maximum dynamic load capacities of WB, EB, WX, and EX were 65.5,
262 45.8, 106.7, and 93.2 kN, respectively. Prior to this point being reached, it was unlikely for the
263 specimens to undergo disproportionate collapse even if a sudden column failure occurred. The
264 maximum dynamic deformations of WB, WX and WV were 380, 380, 200 and 320 mm, which were
265 163%, 194%, 167% and 250% of that of maximum static deformations, respectively. This implied that
266 the deformation capacity of the frames under sudden column removal were greater than those under
267 quasi-static loading for the same applied load.
